NATIONAL PROGRAM FOR INSPECTION OF NON-FEDERAL DAMS
WIGWAM RESERVOIR DAM (..U) CORPS OF ENGINEERS WALTHAM
MA NEW ENGLAND DIV MAY 79

U.S. ARMY ENGINEER DIV. NEW ENGLAND CORPS OF ENGINEERS WALTHAM, MASS.	NATIONAL PROGRAM OF INSPECTION	OVERVIEW PHOTO WIGWAM RES. DAM BRANCH BROOK
PHILIP W. GENOVESE AND ASSOCIATES, INC. ENGINEERS-HAMDEN, CT.	OF NON-FED DAMS	WATERTOWN & THOMASTON, CONN. CE. NO. _____ DATE _____ PAGE _____

WIGWAM RES SOUTH DAM
BRANCH BROOK
WATERTOWN, CONN.

NATIONAL DAM INSPECTION PROGRAM
PHASE I INSPECTION REPORT

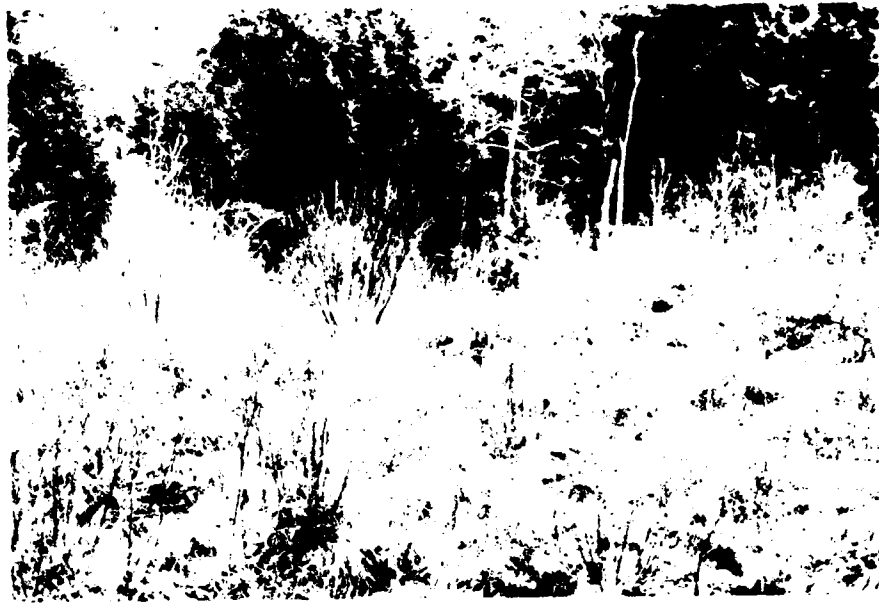
The spillway discharge channel is generally in good condition except for the overgrowth of brush and trees.

PHOTO NO. 7 - View looking east along spillway channel
from location approximately 8' downstream
from spillway crest.

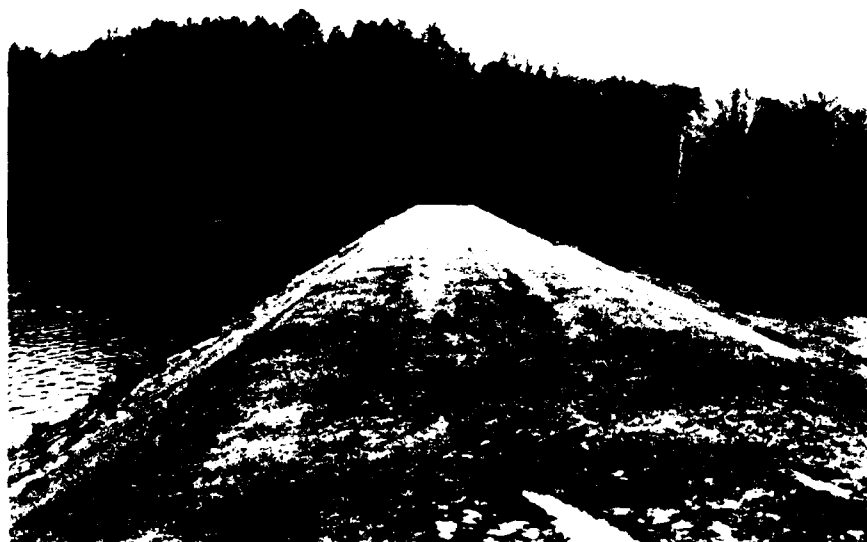
PHOTO NO. 3 - Looking
along downstream
face of dam from
100 feet right (south)
of spillway. Apparent
wet area near toe of
slope, topographic
suggestion of drain-
age channel.
